## The Characterization of Welded AA 5005 Alloy with AA 5356 Filler Metals According to Slow Welding Rate Using by MIG Welding Technique

The main goal of this study was to investigate the weldability, hardness and tensile properties and microstructural investigations of weld joints of marine AA 5005 alloy at low welding speed by using AA 5356 filler material.

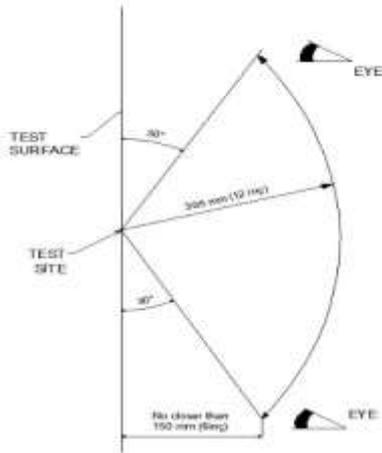
surrounding areas to detect any surface defects, discontinuities, or irregularities that could potentially compromise the integrity of the weld joint. Control criteria can be seen in Figure 1. Before control, weld beat was cleaned with a wire brush after then, the visual control of the weld beat was performed under 160 lux lighting conditions.

Figure 1. TS EN ISO 10042 control criteria

The visual test results of the weld bead were examined and it was found that it complies with the

TS EN ISO 10042 B criteria. During visual inspection, the weld bead and surrounding areas are carefully inspected for visible defects, discontinuities or irregularities. Inspection revealed that the weld piece displayed a satisfactory appearance with no signs of significant defects that could compromise its quality or structural integrity. The weld joint was observed to be well formed and free of any visible cracks, lack of melting or porosity.

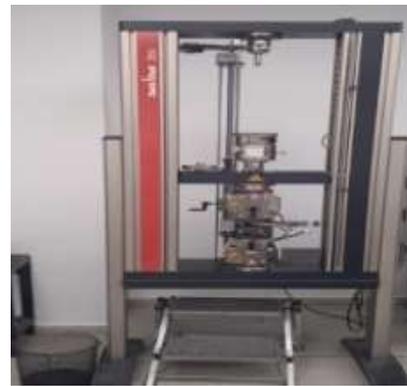
After grinding the weld seam, a tensile strength test was carried out for the welded parts. Welded parts are meticulously prepared in accordance with ASTM E-8 standard and ground to ensure homogeneity. The samples obtained in this way were subjected to tensile strength test using Zwick Roell Z050 Tensile Test Machine (Figure 2). The test speed was 10 mm/min and the load was 50 kgf. By recording the data obtained during the experiment, it was checked whether the welded joint is within the range of tensile strength values recommended in the literature.

Figure 2: Zwick Roell Z050 Tensile Test Machine

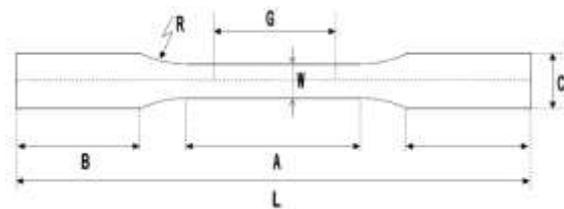
Tensile test specimen dimensions is shown on the Figure 3.

STANDART	STANDART
G = 50,00 ± 0,10 mm	A = 57 mm (min.)
W = 12,50 ± 0,05 mm	B = 50 mm
R = 12,5 mm (min.)	C = 20 mm
L = 200 mm (min.)

Figure 3: Tensile test specimen and its dimensions

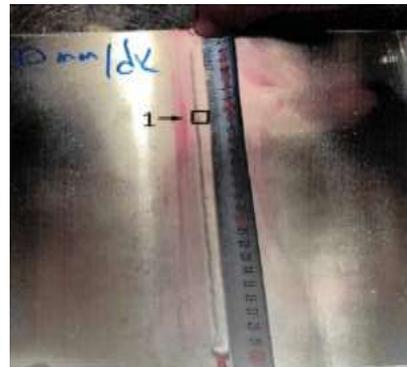
The penetration test results of the weld bead were examined; < 3 mm surface porosity has been seen on the bead. This porosity had been occurred due to slow welding speed [9]. Porosity can be seen at Figure 4. But according to the TS EN ISO 23277 Level II standard, this scaled porosity is allowed. The penetration test involved inspecting the weld bead for any indications of incomplete fusion or penetration. The examination revealed that the weld bead exhibited satisfactory fusion and penetration, meeting the requirements specified in the TS EN ISO 23277 Level II standard. There were no indications of incomplete fusion or lack of penetration, indicating that the welding process was performed effectively, and the weld joint had achieved the desired level of fusion and penetration.

**Figure 4:** Penetration Test

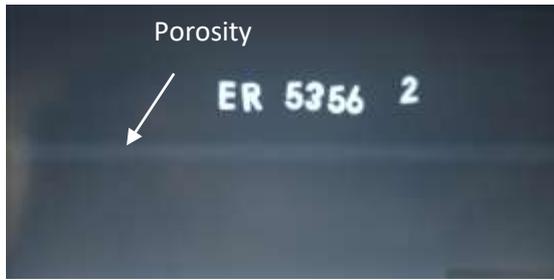
In the radiography test conducted in this study, porosities were identified, similar to the observations in the penetration test. Similar to the findings of Zhan et al., it was observed that low welding speeds can lead to porosity formation. Some porosity formation was also observed at 780 mm/min welding speed. [15]. X-ray can be seen at Figure 5.

**Figure 5:** X-Ray of weld seam

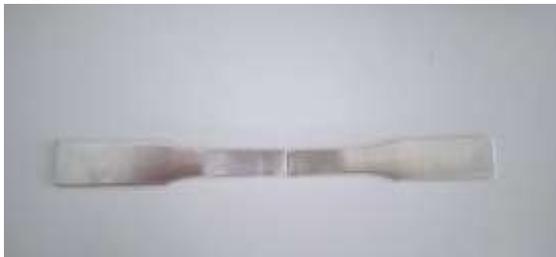
The tensile test results, in accordance with TS EN ISO 15614-2 standard, met the condition of equal to or above "0" (Original condition; H<sub>0</sub>) for the tensile strength. During the test, the test part was broken apart from the heat-affected zone (HAZ) (Figure 6). The yield strength was measured at 88 MPa, and the tensile strength recorded at 110 MPa (Table 5), the tensile strength minimum requirement of "0" condition tensile strength, which is set at 100 MPa. The successful outcome of the tensile test demonstrates the weld joint's excellent mechanical properties, as it withstood the applied tensile forces well above the minimum threshold. These results affirm the weld's reliability and structural integrity, meeting the stringent criteria outlined by the TS EN ISO 15614-2 standard.

**Figure 6:** Sample after tensile test.

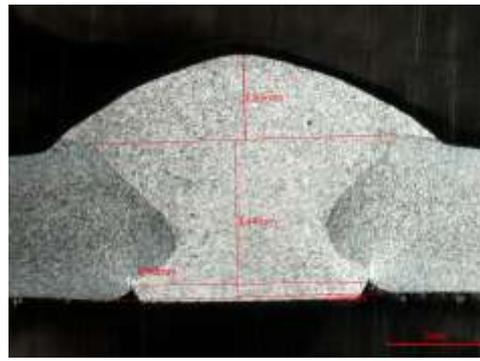
The macro test image (Figure 7) revealed the formation of a weld bead with a width of 4.90 mm and a depth of 3.44 mm. The height of the weld bead was measured to be 1.83 mm. These measurements indicate the dimensions and overall appearance of the weld bead on a larger scale.

**Figure 7:** Macro image of welding

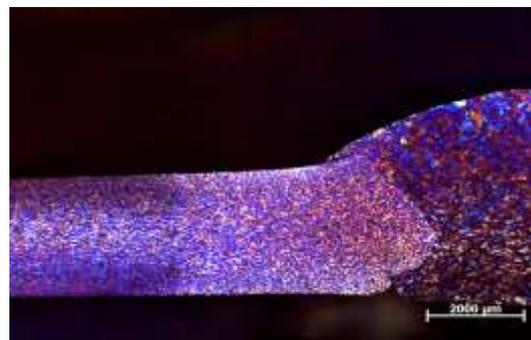
The micro test results revealed significant findings along the transition from fiber grains to recrystallization and regrowth grains. The examination displayed distinct microstructural changes, illustrating the transformation from initial fiber-like grains to newly recrystallized grains (Figure 8). Additionally, the presence of regrowth grains was evident, indicating the material's response to the welding thermal influence during welding. The differentiation of grain types from the base metal to the HAZ and fusion zone has significant implications for the mechanical properties and overall performance of the weld joint. The finer grain structure in the HAZ can lead to enhanced mechanical strength and improved resistance to certain forms of corrosion. On the other hand, the coarser grain structure in the fusion zone may result in reduced mechanical properties, such as lower tensile strength and increased susceptibility to brittle [13].

**Figure 8:** Transition of grains

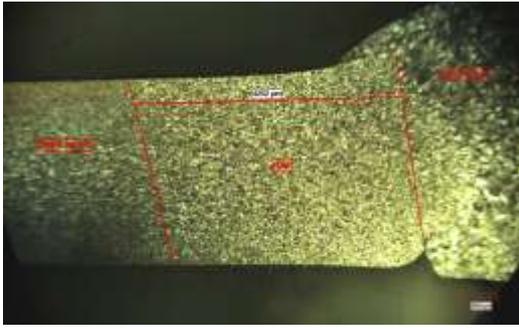
**Figure 9:** HAZ measurement

HAZ length was measured as 4252 microns (Figure 9). Grain size measurement using the intercept method revealed distinct differences between the heat-affected zone (HAZ) and the fusion zone. The HAZ exhibited an average grain size of 33.99  $\mu\text{m}$ , indicating a finer microstructure compared to the fusion zone. In contrast, the fusion zone displayed a larger average grain size of 68.94  $\mu\text{m}$  (Figure 10 and 11), suggesting coarser grains within this region.

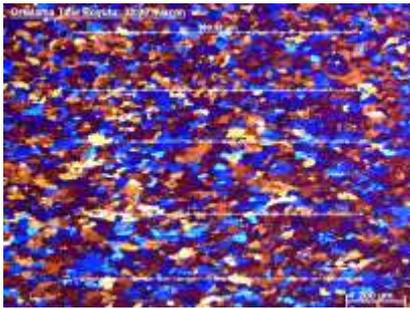
**Figure 10:** HAZ grain size measurement

1. The welding conducted at 780 mm/min welding speed was deemed suitable in terms of mechanical properties. However, during the radiographic and metallographic examinations, certain drawbacks were observed due to the low welding speed, resulting in high heat input. Grain size of heat-affected zone (HAZ) and the fusion zone are 33.99  $\mu\text{m}$  and 68.94  $\mu\text{m}$ , respectively.

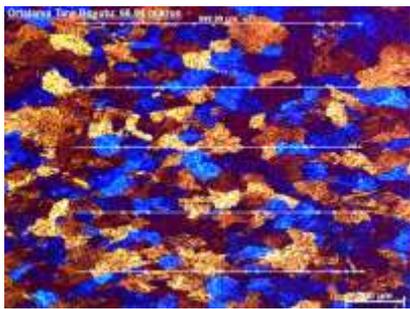
**Figure 11:** Fusion zone grain size measurement

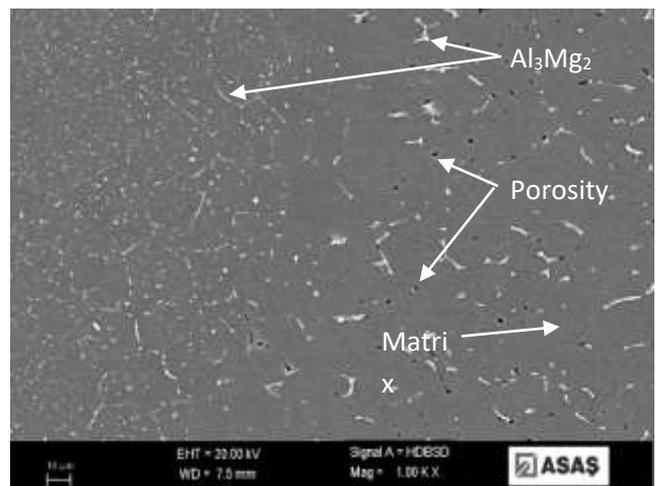
The SEM analysis revealed the presence of small and numerous white contrasted particles in the microstructure. Additionally, black contrasted areas were observed, indicating the formation of porous regions in the weld metal. The effect of heat input during the welding process resulted in the occurrence of coarse and large-sized intermetallic

phases within the welding zone. These findings provide valuable insights into the microstructural characteristics of the weld, shedding light on the distribution of particles and porosity, as well as the impact of heat on the formation of intermetallic phases. During the welding process, hydrogen can be introduced into the molten weld pool from various sources, such as moisture, contaminants, or the electrode coating. As the weld solidifies, the hydrogen can become trapped within the metal structure, forming hydrogen gas bubbles. These gas bubbles are responsible for the observed black contrast in the micrographs. The slow welding speed plays a crucial role in the hydrogen entrapment phenomenon. When the welding speed is slow, the solidification of the weld metal occurs at a slower rate. This extended solidification time provides more opportunities for the hydrogen atoms to diffuse and become trapped within the microstructure, leading to the formation of the black contrasted particles [14]. SEM image can be seen at Figure 12. Especially white parts took place grain boundaries and, in the grains are intermetallic phase ( $\text{Al}_3\text{Mg}_2$ ) together with  $\alpha$ -matrix phase (constituent gray parts). M.Bilgin et.al explained that the Al-Mg alloys includes  $\text{Al}_3\text{Mg}_2$  and  $\text{Al}_{12}\text{Mg}_{17}$  intermetallic phases in the welding zone and matrix (Figure 13) [16].

**Figure 12:** SEM image at BSE mode

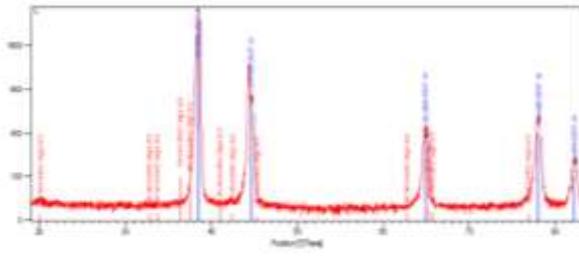
Figure 13: XRD analysis of the weld zone

The weld zone was characterized by XRD analysis (Rigaku D/Max which has a wavelength of 1.54056 Å with a Cu Kα radiation).

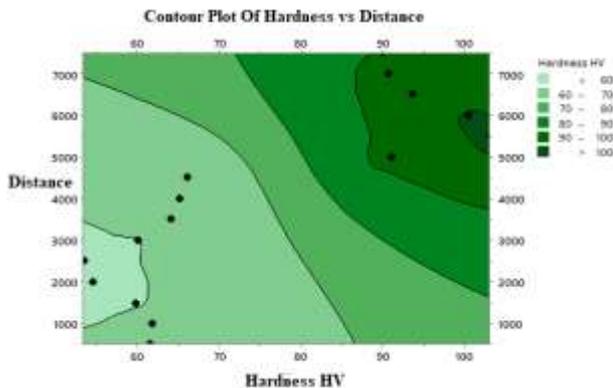
The hardness test results showed findings as the measurements transitioned from the base metal to the recrystallized heat-affected zone (HAZ) region. During this transition, the hardness values were observed to decrease. Although, in the weld bead characterized by grain growth, a notable increase in hardness up to 100 HV was observed, because of the including higher alloying elements including filler materials composition. These results highlight the significant influence of microstructural changes on the material's hardness properties within different regions of the weld joint. Microhardness Contour Graphic can be seen at Figure 14.

Figure 14: Microhardness Contour diagram

Hardness measurements were carried out on the samples using the Zwick Roell ZHV 10 microhardness tester, in which sequential measurements were taken at 500 micron intervals starting from the base metal, according to the ASTM- E92 standard. In these measurements, applied loads and dwell times are 10 grf and of 15s, respectively. In this way, a Microhardness Contour diagram was obtained using by Minitab 19 software.
