Architectural Transformations and Planning Regulation Violations in Residential Housing Allotments: A GIS Approach in Zouaghi Slimane-Ain El Bey, Phase 2, Constantine (Algeria)

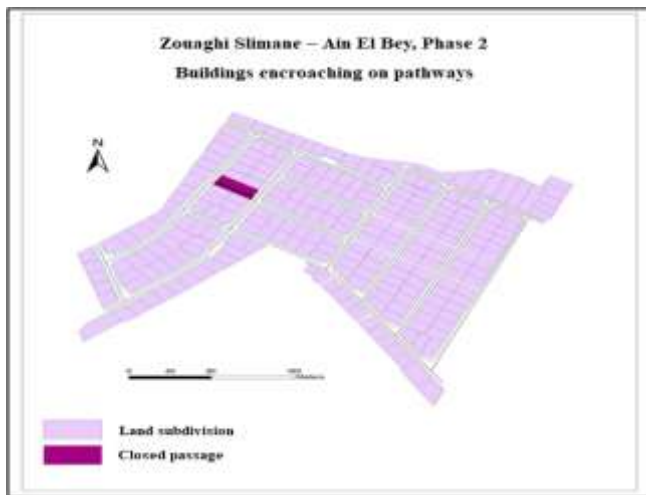
Figure 13: Violations encroaching on pedestrian pathways across the study area

Only two buildings encroach upon designated pedestrian pathways, violating public property rights (Figure 13).

These infractions are the result of property owners expanding their private areas at the expense of public spaces, again with minimal regulatory oversight.

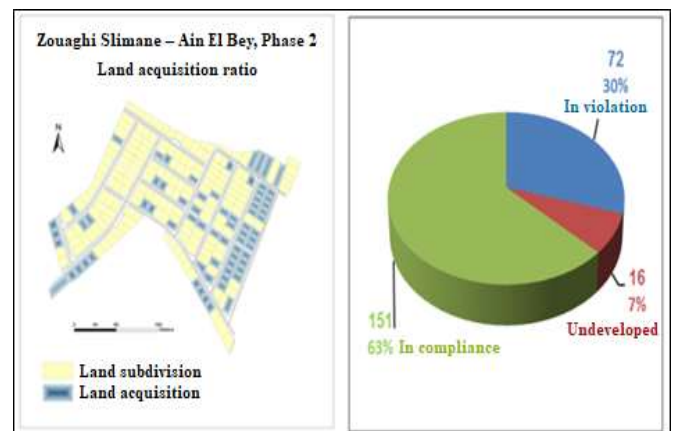
Figure 16: Land occupancy coefficient violations across the study area

The Land Occupation Coefficient (CES) was set between 0.4 and 0.6, yet 72 buildings (30%) exceed this limit, particularly on the eastern side of the allotment (Figure 16). These violations result from owners fully utilizing their plots, neglecting the mandatory green spaces, and reflect inadequate monitoring. The direct cause of these buildings' violations of the land occupancy coefficient is always the owners themselves, who carried out extensions by fully utilizing their plots (constructing on the entire land without leaving the designated space for gardens).

In addition, the absence of oversight and monitoring by authorities and relevant agencies has contributed to the proliferation of these violations within the allotment.
